Evaluation of Concrete Consolidation: DSS-35 Antenna Reinforced Concrete Pedestal Canberra Deep Space Communications Complex, Australia

Benjamin P. Saldua,* Ethan C. Dodge,† Peter R. Kolf,† and Carlton A. Olson†

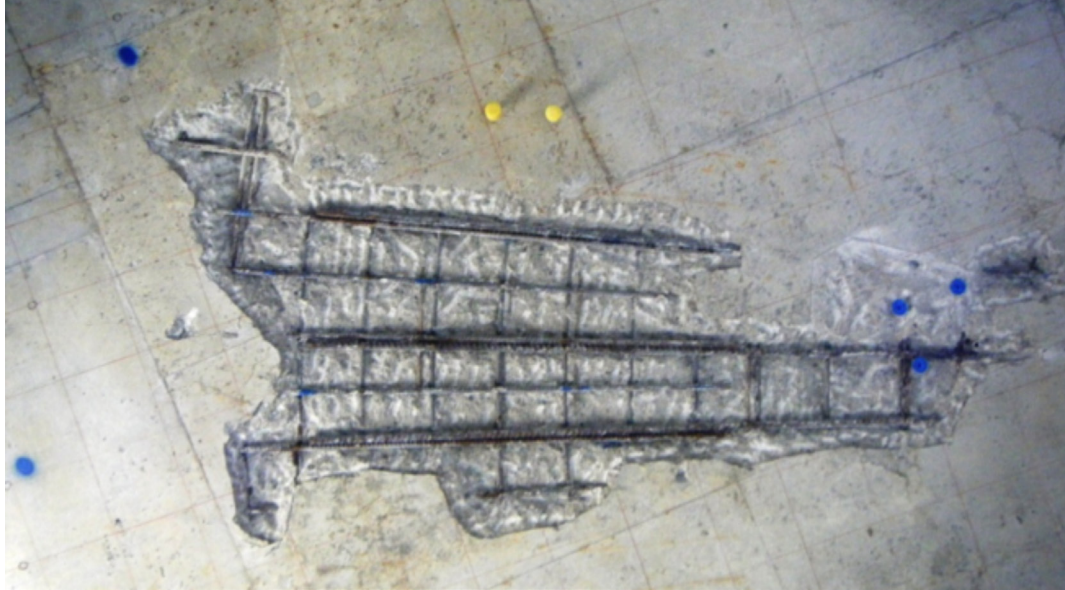
Concrete placement of the roof slab and outer track wall began by filling the outer track forms and adjacent main roof slab to approximately the roof slab final elevation and then continued from the center outward in wedge shaped sections (Figure 2). After the outer track had stiffened enough to be filled above the main slab elevation, the final layer was placed and the lifts vibrated together. Experience has shown that the most likely problem areas would be the lift line between outer perimeter lifts and below the lap splices of the upper and lower reinforcing mats in the roof slab. Poor concrete consolidation was visible at the roof slab underside below the lower mat lap splices at the time of form removal. These locations had been chipped to sound concrete at the time that the investigation commenced (Figure 3).

Figure 3. Concrete removal identified bar laps at a location of voiding at the slab soffit.

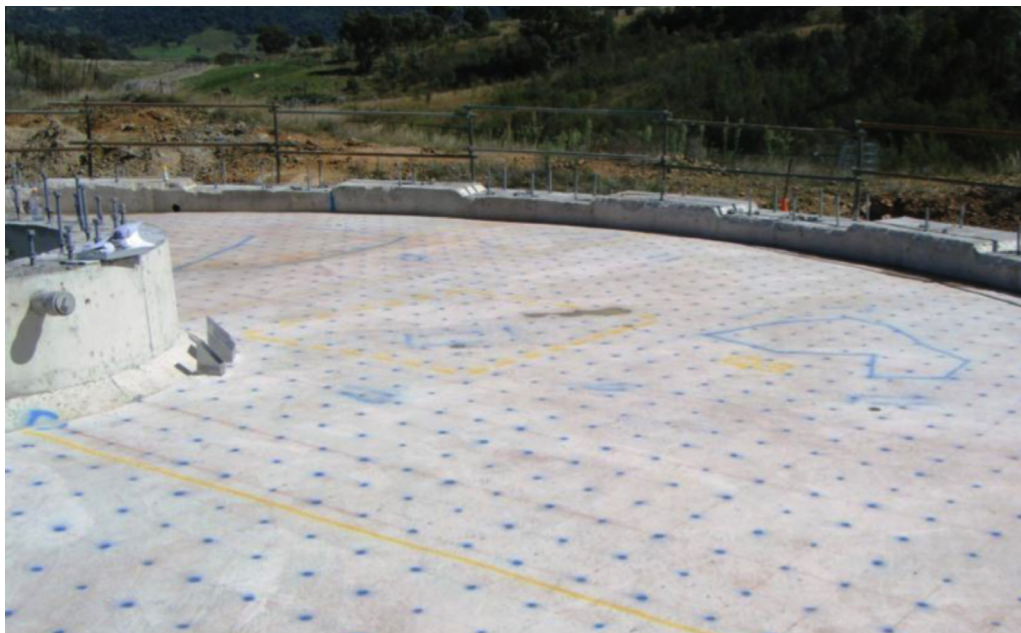
Figure 4. Test grid marked on slab topside (blue lines outline underside concrete removal areas).

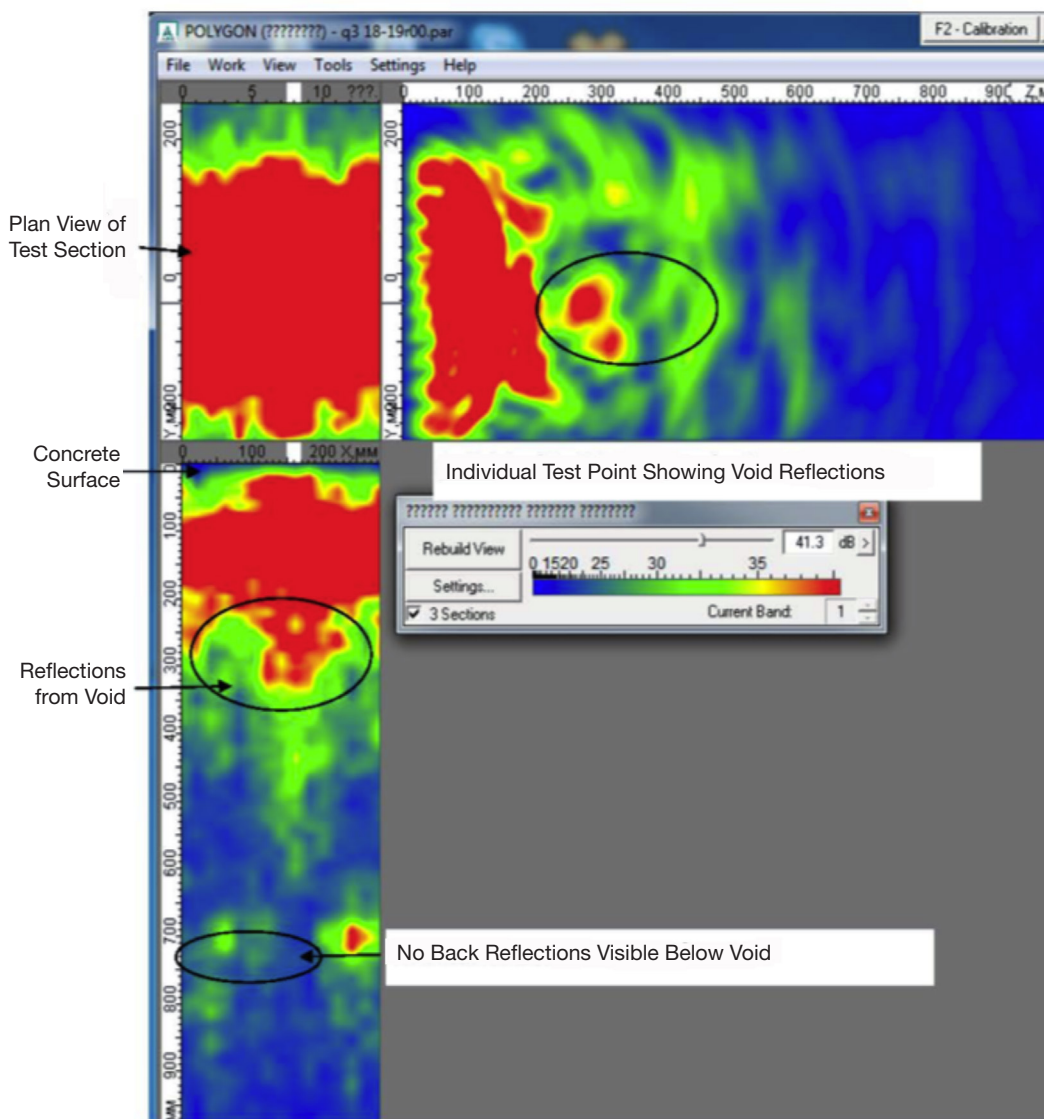
A significant void below the top reinforcing steel was distinguishable from the MIRA test results (Figure 7) at the location of Core CTL-2. However, in areas with material variations such as an increase in entrapped air pockets or the cold joint at the location of Core CTL-3, significant defects could not be distinguished by MIRA.

Figure 7. MIRA data showing a void below the upper reinforcing steel near the location of Core CTL-2.

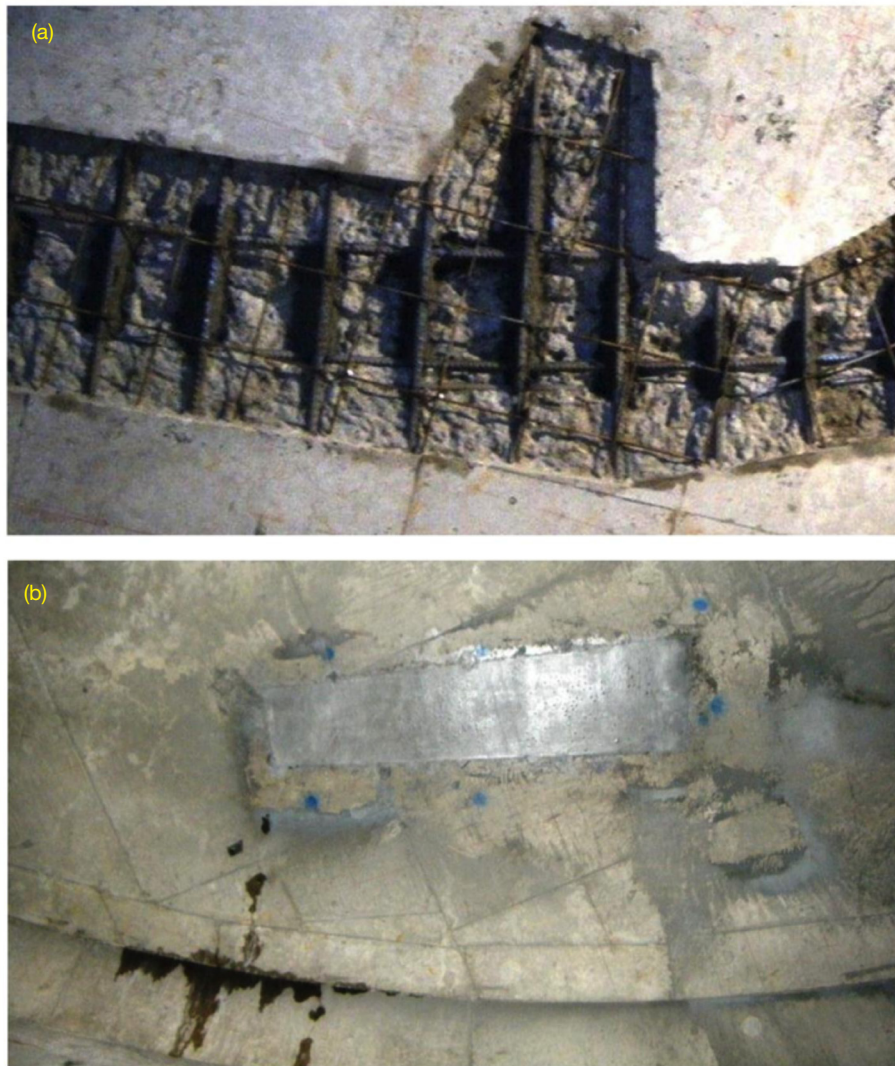
- (1) *Soffit* — As expected, and as demonstrated by the IR test results, significant defects on the slab underside were limited to primarily the lap spliced zones under the lower reinforcing mat. Shotcrete was selected as the repair material for the soffit repairs. Cavity areas above reinforcing steel were filled with trowel-grade mortar prior to shotcrete application. The preparation, cavity filling and final shotcrete repair are shown in Figure 8.

Figure 8. Soffit repair. (a) Soffit cavity prepared and mortar packed above reinforcing.
(b) Completed shotcrete repair.

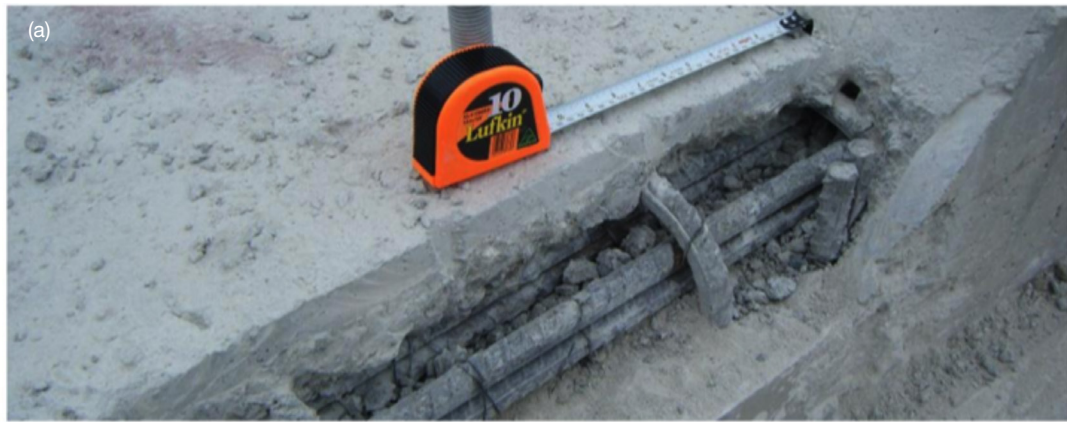
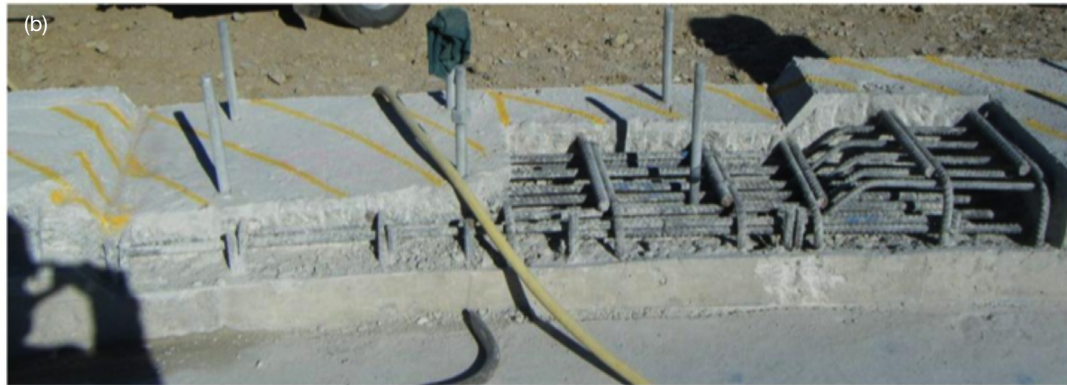
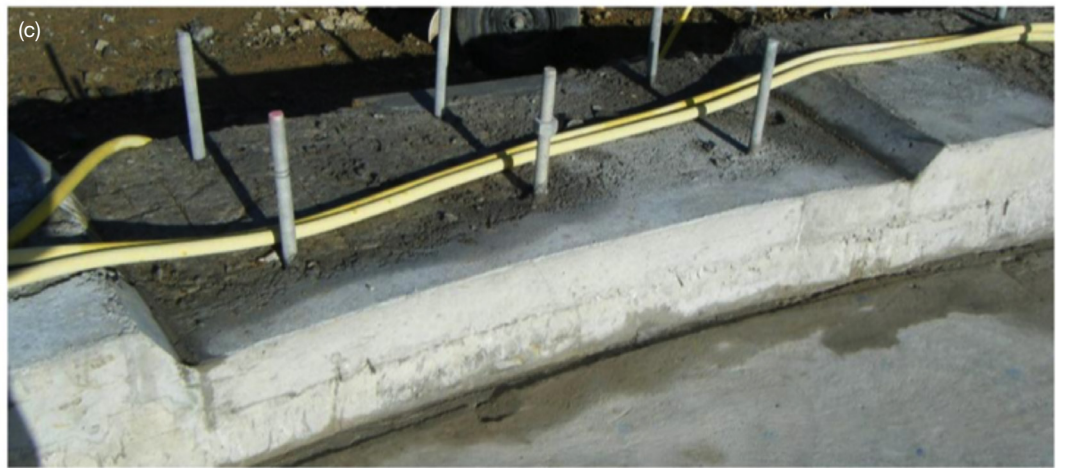
- (2) *Perimeter track* — Presence of significant reinforcing in perimeter track walls precluded the use of nondestructive testing techniques. Therefore, a combination of visual inspection and careful exploratory concrete removal was used to identify areas of concrete for removal and replacement. Voids encountered were generally associated with areas of laps in reinforcing bars. Figure 9 shows repairs to an area of voiding at the track wall.

Figure 9. Track wall repair. (a) Area of poor consolidation at track wall. (b) Poorly consolidated concrete removed and repair area prepared. (c) Completed placement of repair.

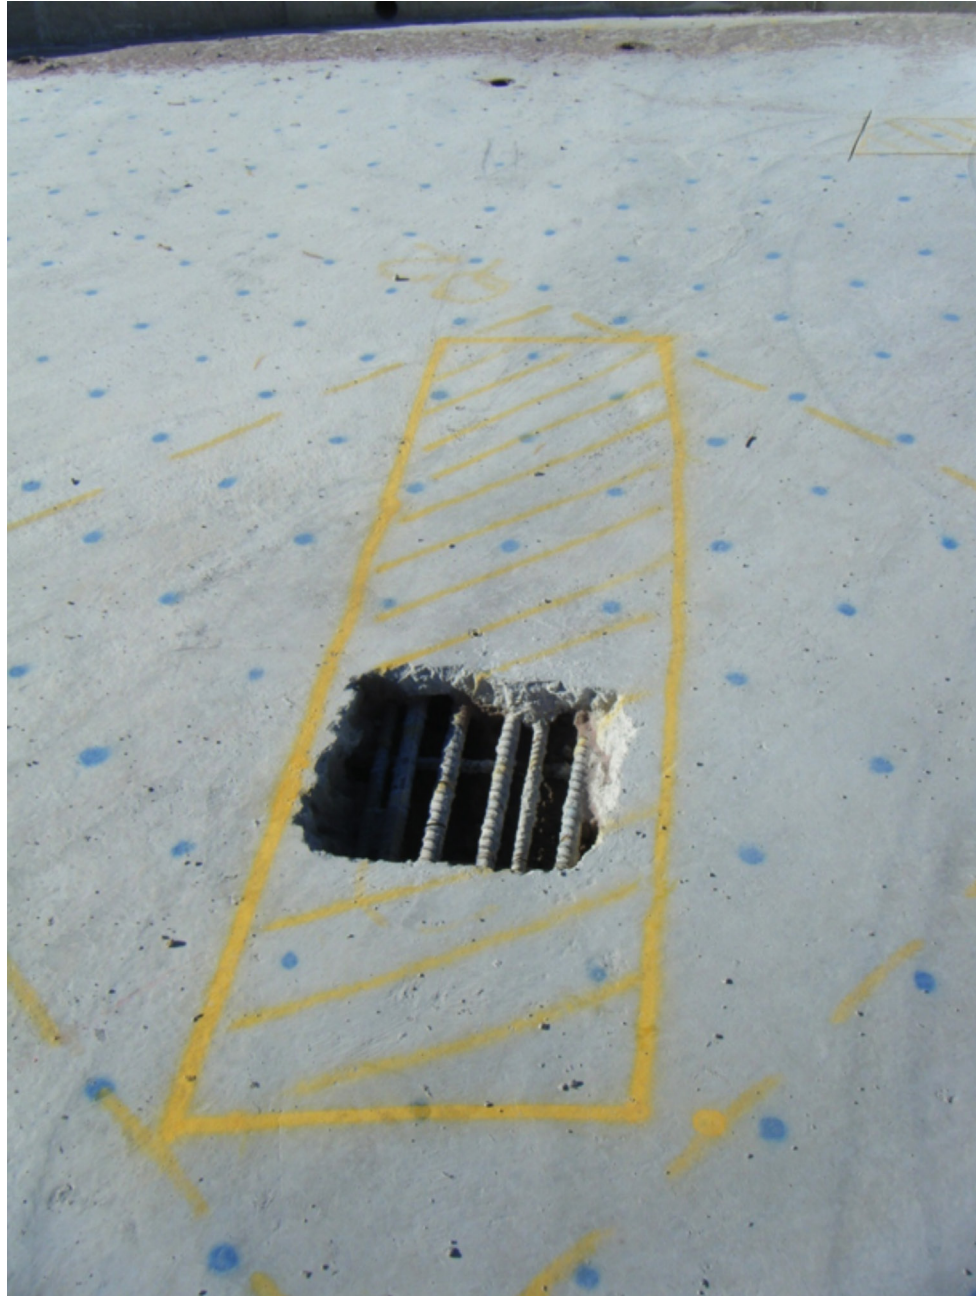
The core location (CTL-2), exploratory opening and the repair extents (in yellow) for a relatively large voided area can be seen in Figure 10. The repair of a voided area is shown in Figure 11. In addition to the repairs stemming from concrete placement delays, a poor bond between the wall placement and the roof slab placement was observed in localized areas. These areas were selected for epoxy injection repairs that are shown in Figure 12.

**Figure 10. Exploratory opening at location of Core CTL-2 encountered significant voiding.
The repair extents are shown in yellow.**

- (3) *Top surface* — The top surface repairs were primarily based off the IR test results as follows:
- A significant void or defect was presumed to exist at any location where the IR mobility test result was 0.475 or higher. Therefore, these locations were marked for concrete repairs. Repair excavations were expanded as necessary to remove any defective concrete.

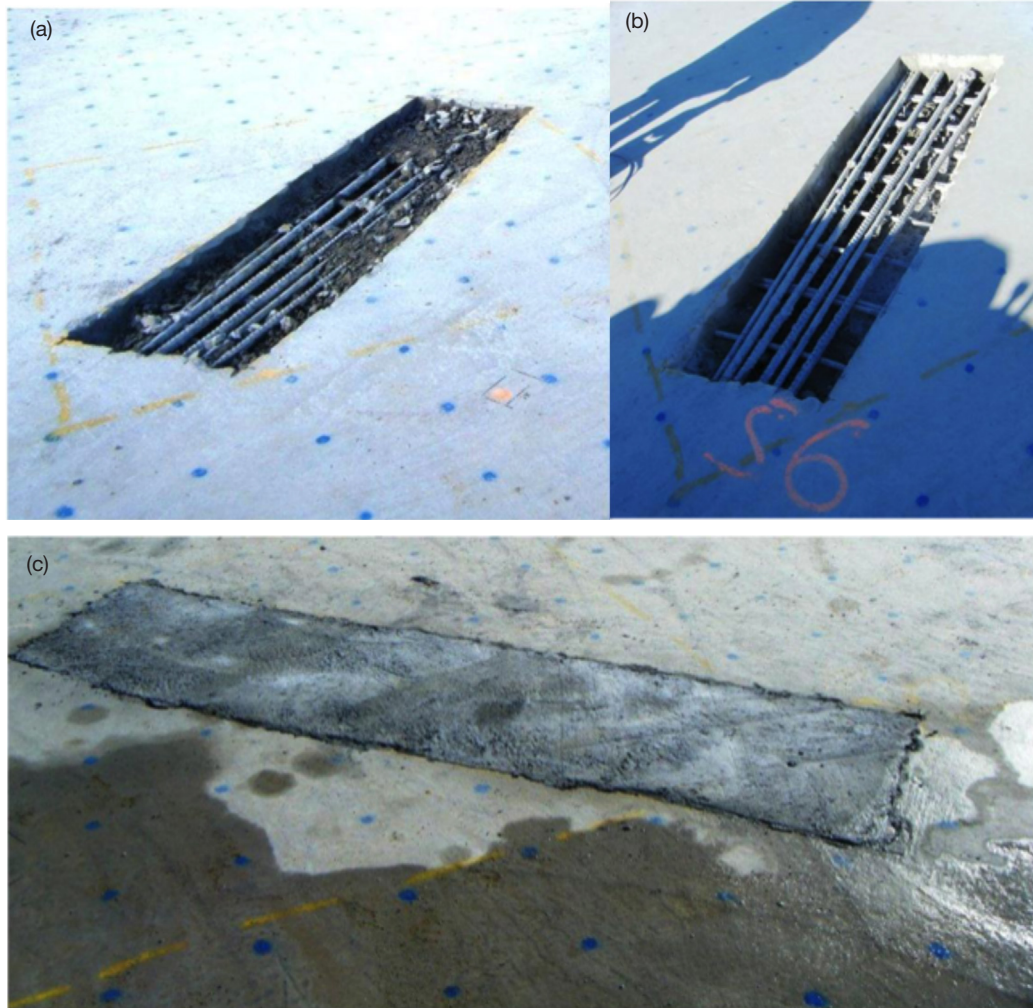
Figure 11. Remove and replace repair for an area with voiding. (a) Initial chipping of marked repair extents. (b) Chipping and inspections completed. (c) Repair concrete cast into prepared cavity.

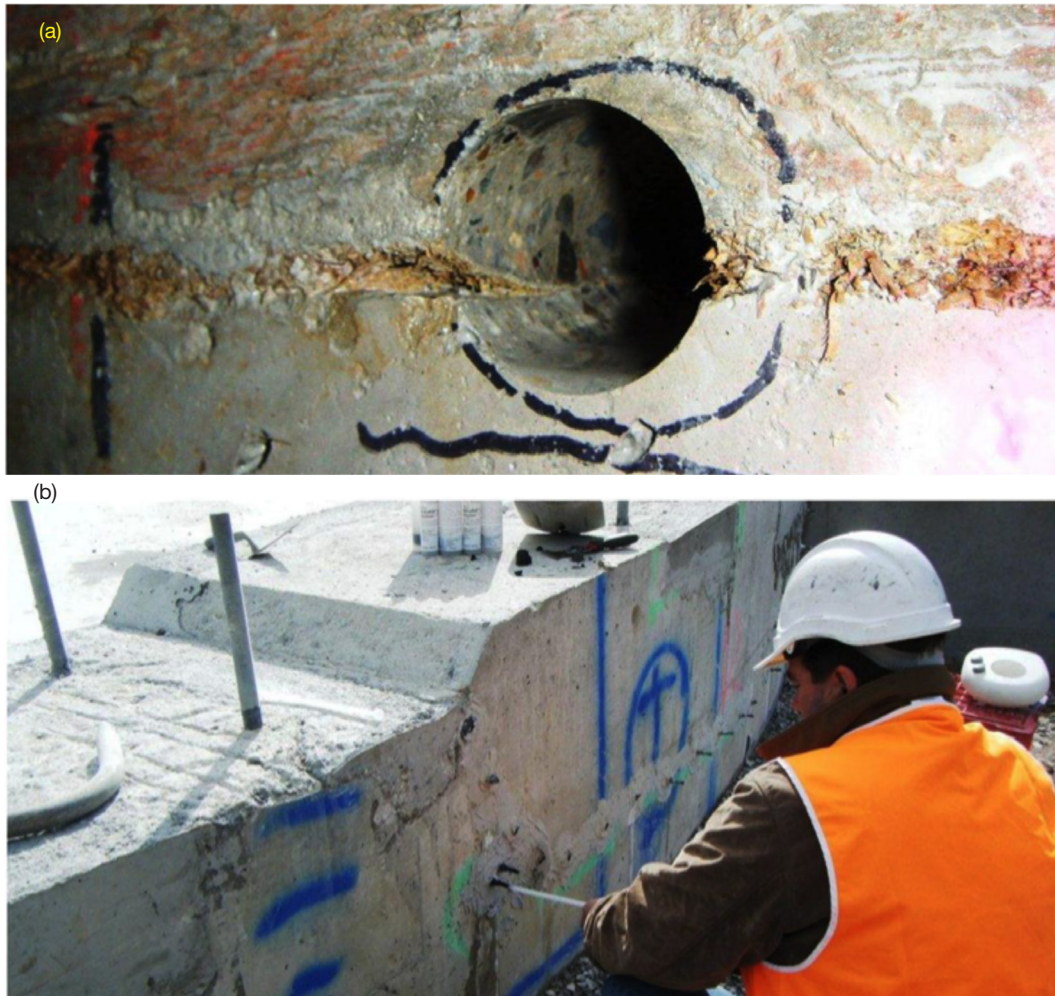
Figure 12. Epoxy injection repairs at construction joint. (a) Areas of poor bond between placements at construction joint. (b) Epoxy injection of construction joint.
